Fraser Gauge and Tool Company

ARE YOU REALLY GETTING WHAT YOU EXPECT FROM YOUR CALIPER SUPPLIER?

The Disc Brake Caliper in this document is from a prominent supplier, and is sold in the market place as a remanufactured Caliper. Our findings, once again, prove that this is just not the case. Wearing parts have been continuously re-used throughout the Caliper, from Guide Pins and Bushings to internal mechanisms. Ineffective re-used parts have caused a serious air leak which would also allow the ingress of water. To compound these issues old revisions of components have been used. These components were upgraded many years ago by the manufacturer.

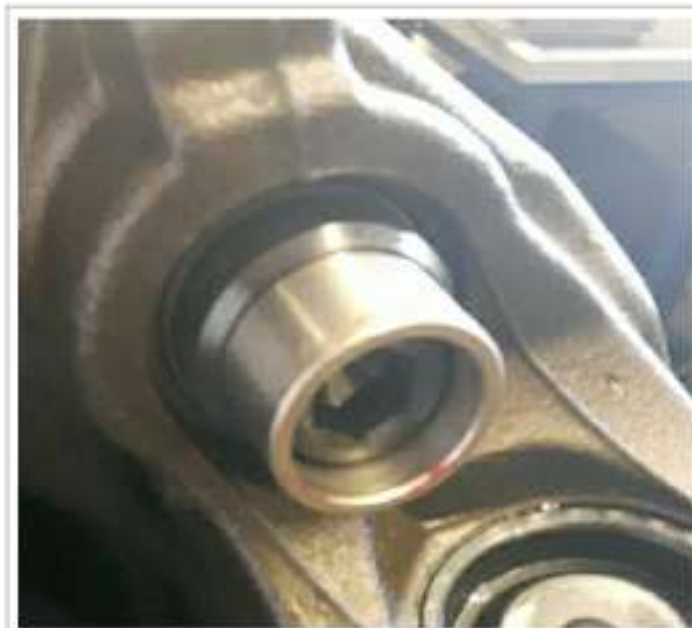
This Rubber/ Metal Bush is the old design revision that Knorr-Bremse replaced some time ago. Fraser Gauge upgrades the most recent.

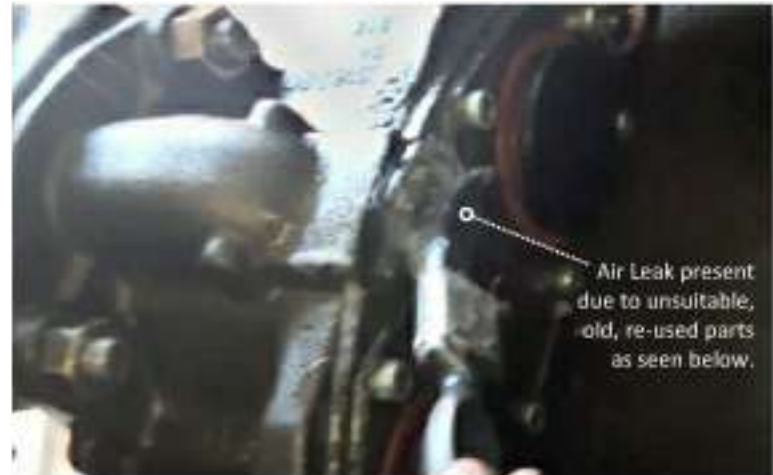
Air Leak present due to unsuitable, old, re-used parts as seen below.

Upon initial inspection a significant air leak was detected. The Steel Plate had been re-used. The Seal fitted to the Steel Plate was also re-used, and an attempt had been made to use a Silicone Sealant to seal the Steel Cover to the main Caliper Casting as seen below. This was unsuccessful, creating this leak, which, when fitted to a vehicle, would result in the ingress of water & therefore, the premature failure of the Caliper.

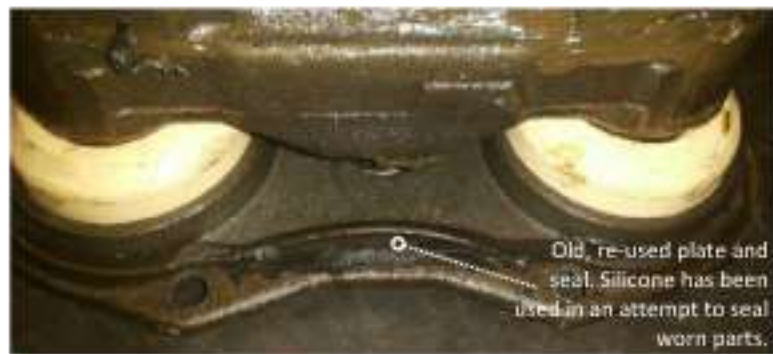
Old, re-used plate and seal. Silicone has been used in an attempt to seal worn parts.

Fraser Gauge always uses NEW Steel Plates & Seals, and tests for air leaks.

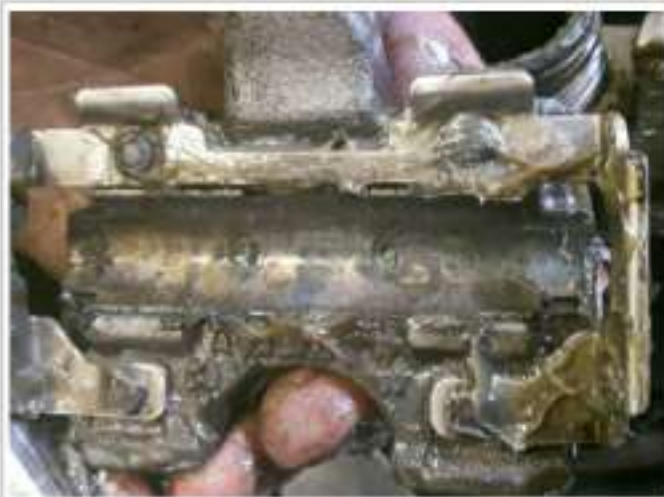
The Lever Bearing was re-used. This is a wearing part.

New Needle Rollers & Shells, new Lever Bearings and new Guide Pins & Bushes EVERYTIME!

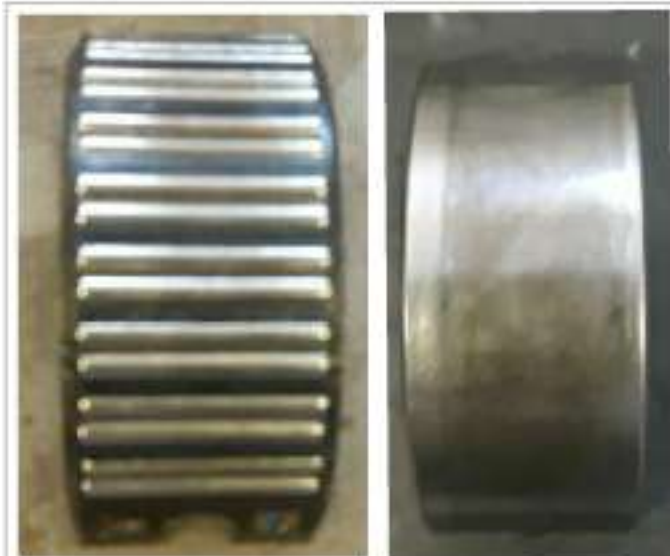
The Needle Rollers & Shells had been re-used. The Needle Rollers especially are a wearing part.

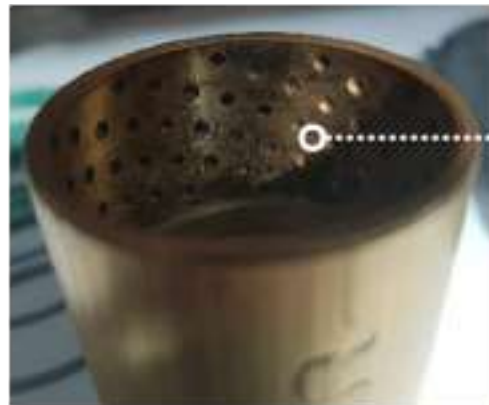
Evidence of previous use and score marks present where an attempt has been made to polish away.

The large Guide Pin Bush was an Original Knorr-Bremse Bushing had been re-used. An attempt had been made to "Polish" this Bush. This is a wearing Part. Fraser Gauge has always discarded the Old Bushings, and replaced with NEW. The Large Guide Pin was re-used. This is a wearing Part. Fraser Gauge have always supplied NEW Guide Pins.

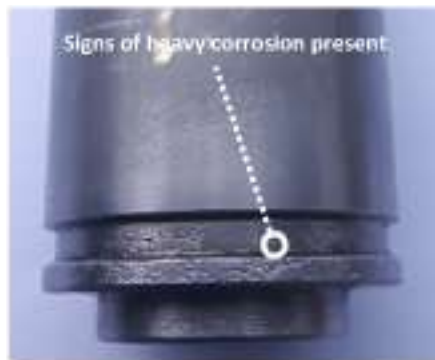
Signs of heavy corrosion present.

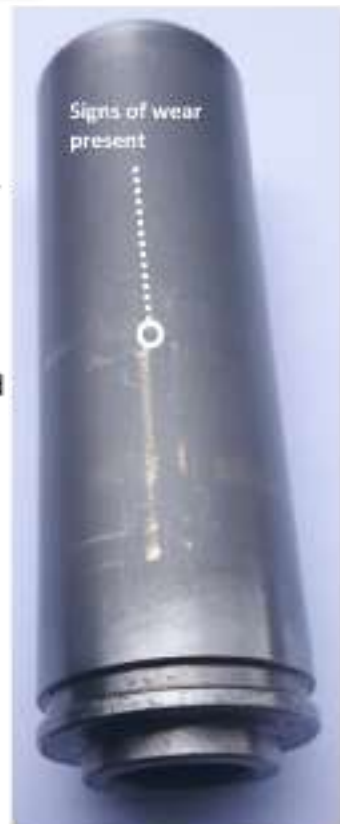
Signs of wear present

You can check for re-used Guide Pins and Bushes yourself by simply removing the large Guide Pin from the Caliper bore and wiping away any grease surrounding it. If you can see wear marks, corrosion or other signs of damage similar to what can be seen in the pictures above then these parts have been re-used. If this corner has been cut then it is most likely that other wearing parts have also been re-used. Parts such as these are something that you should be getting brand new AS STANDARD when buying a REMANUFACTURED Disc Brake Caliper.
